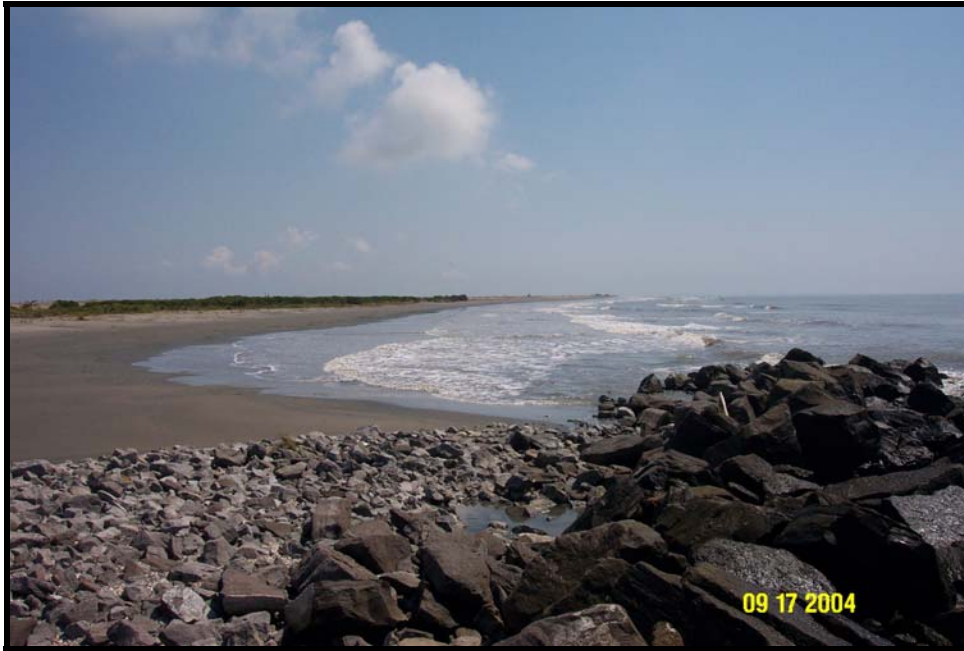
Photo 1. Post-Hurricane Ivan: View of beach fill, standing on top of existing rock shoreline protection at appx. Sta. 100+00 looking east (tide: appx. 1.3' NAVD)

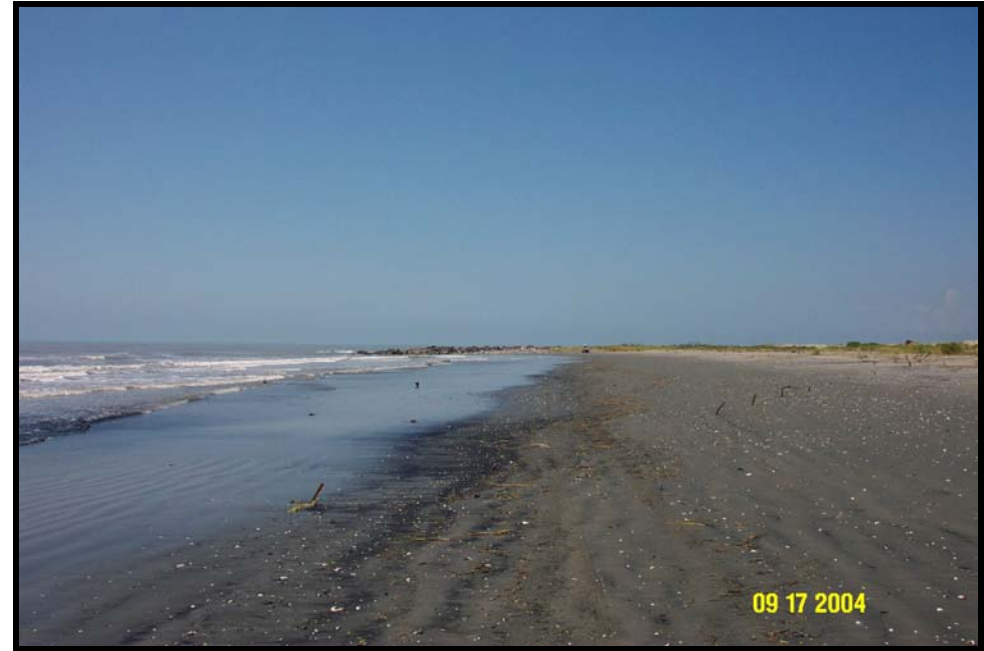
Photo 3. Beach fill Sta. 105+00, looking west

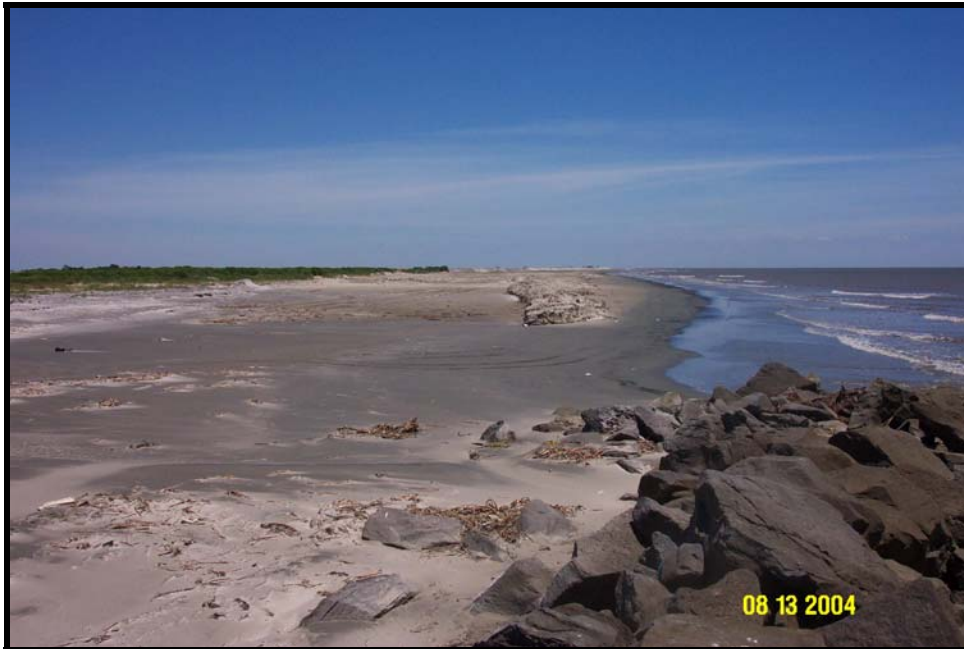
Photo 2. Pre-Hurricane Ivan: View of beach fill, standing on top of existing rock shoreline protection at appx. Sta. 100+00 looking east (tide: appx. 1.5' NAVD)

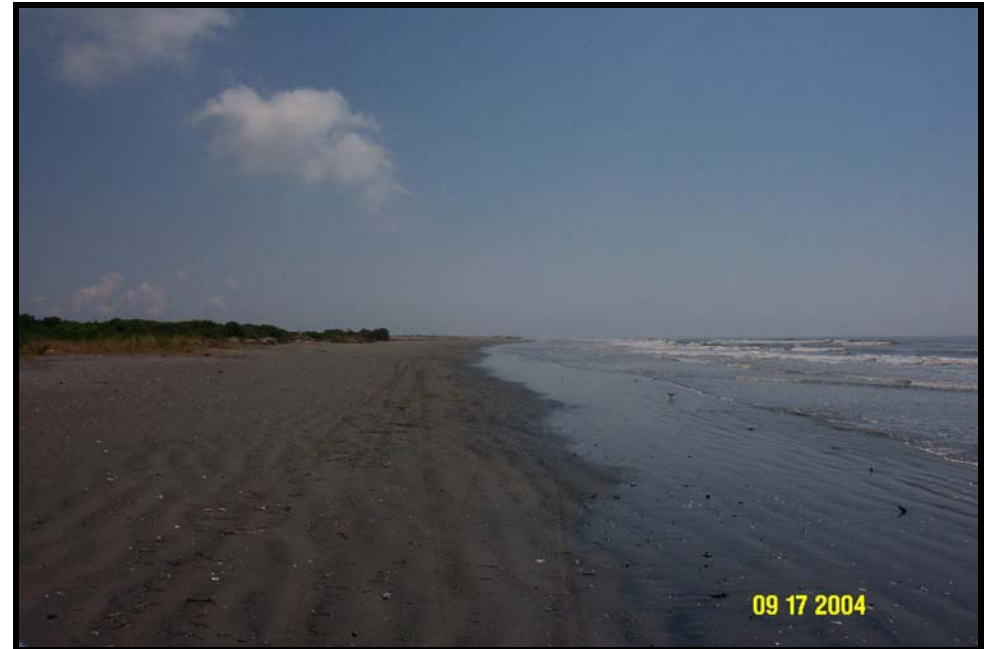
Photo 4. Beach fill Sta. 105+00, looking east

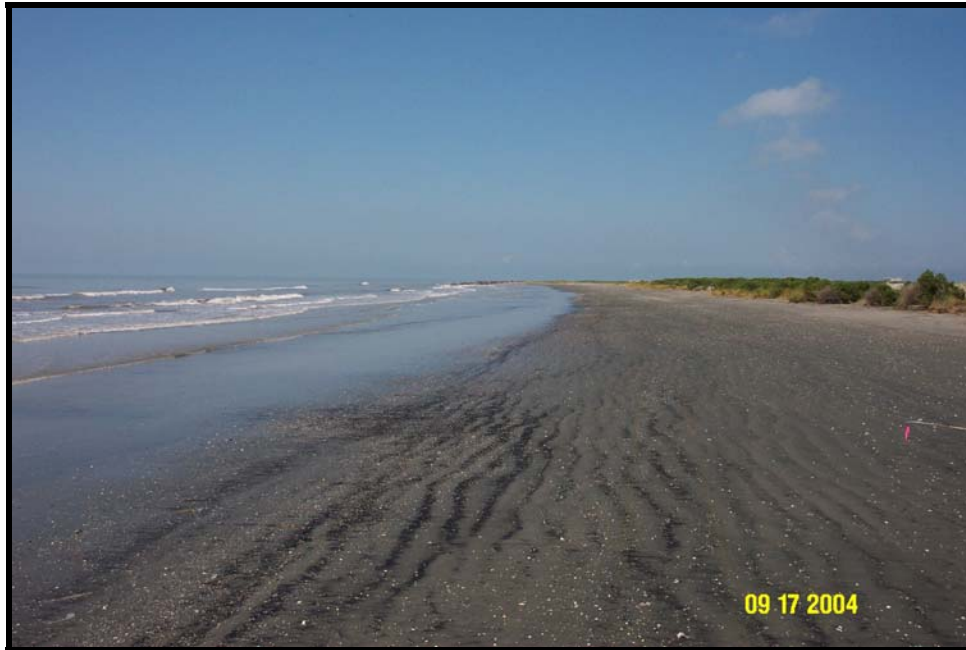
Photo 5. *Beach fill Sta. 110+00, looking west*

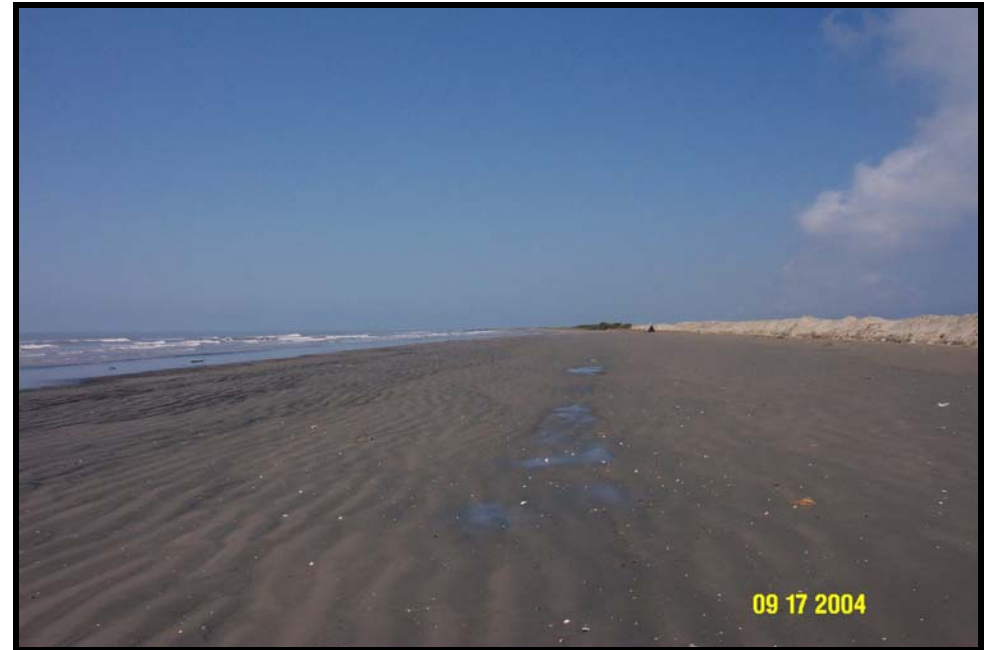
Photo 7. *Beach fill Sta. 125+00, looking west*

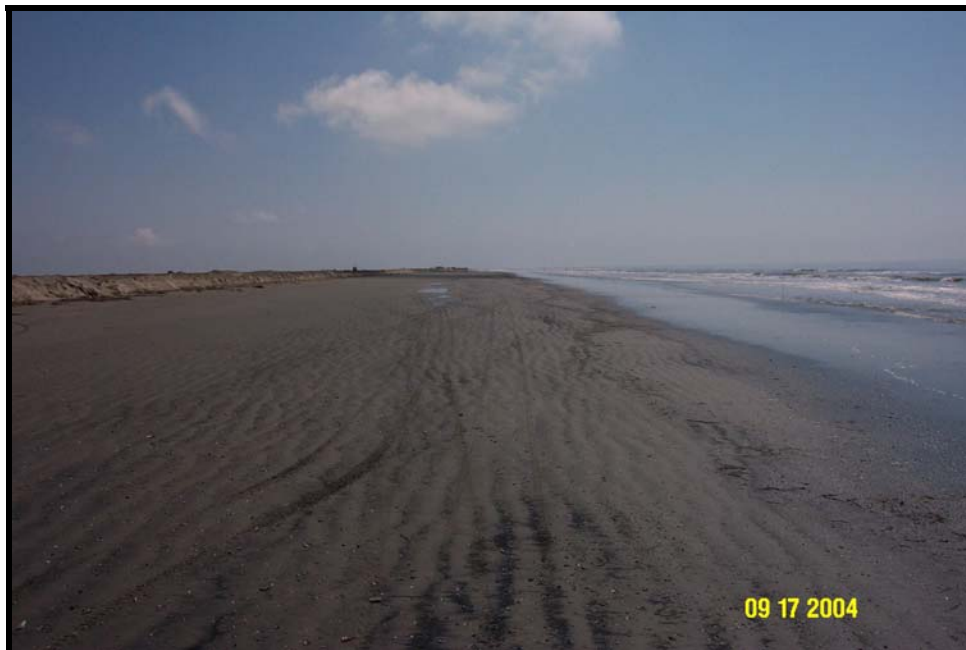
Photo 6. *Beach fill Sta. 110+00, looking east*

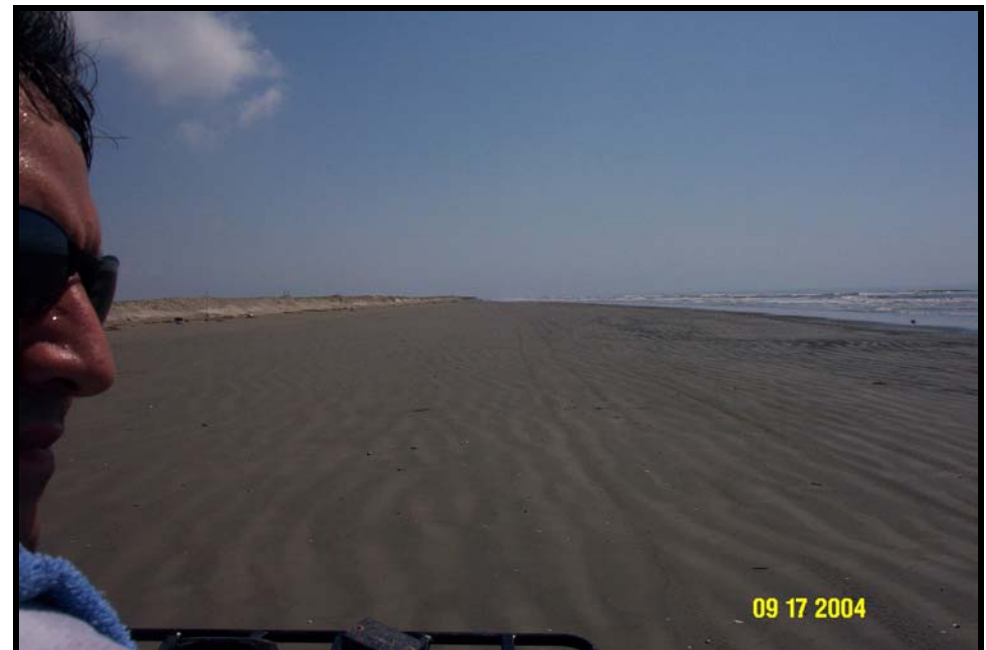
Photo 8. *Beach fill Sta. 125+00, looking east*

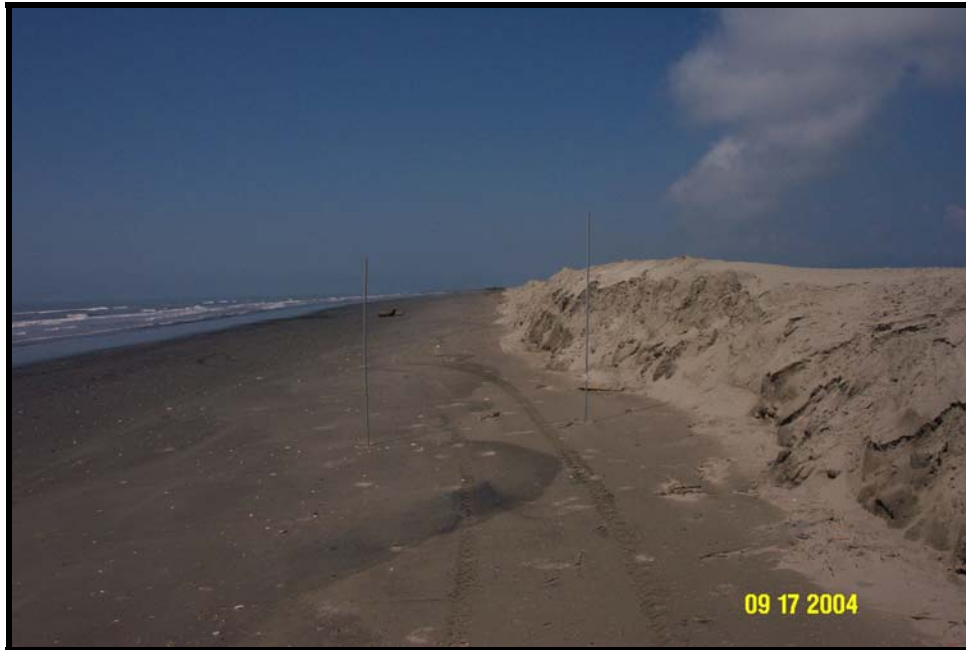
Photo 9. *Front dike erosion Sta. 135+00, looking west*

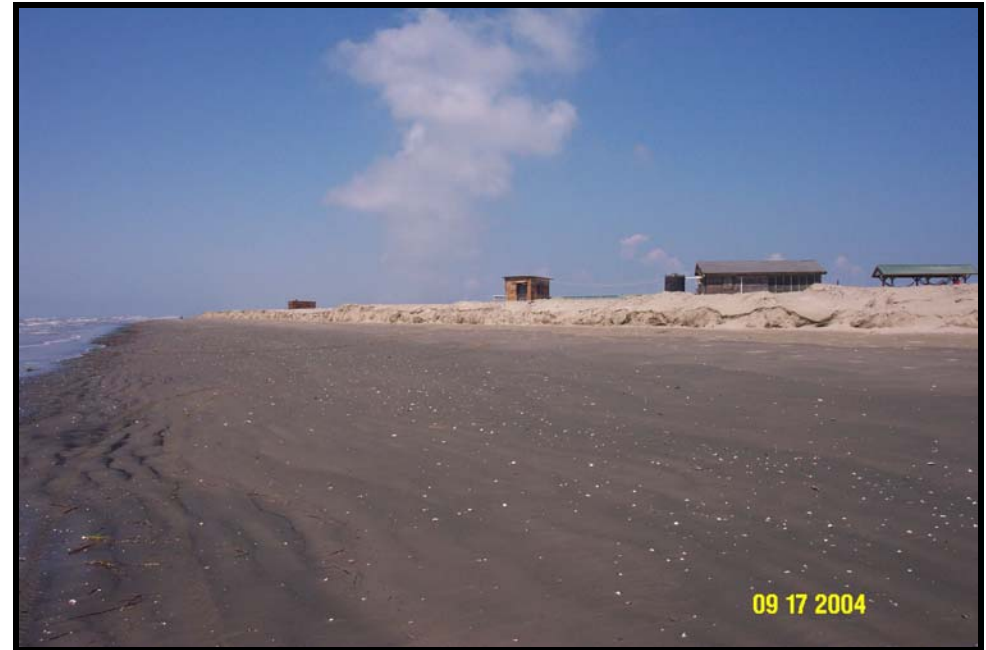
Photo 11. *Beach fill Sta. 168+00, looking west*

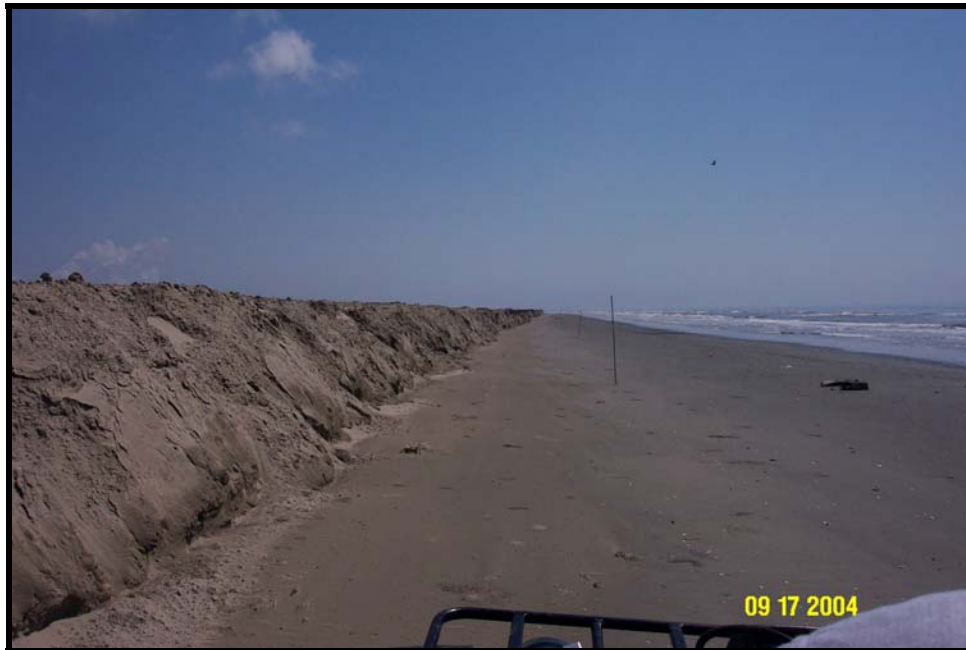
Photo 10. *Front dike erosion Sta. 135+00, looking east*

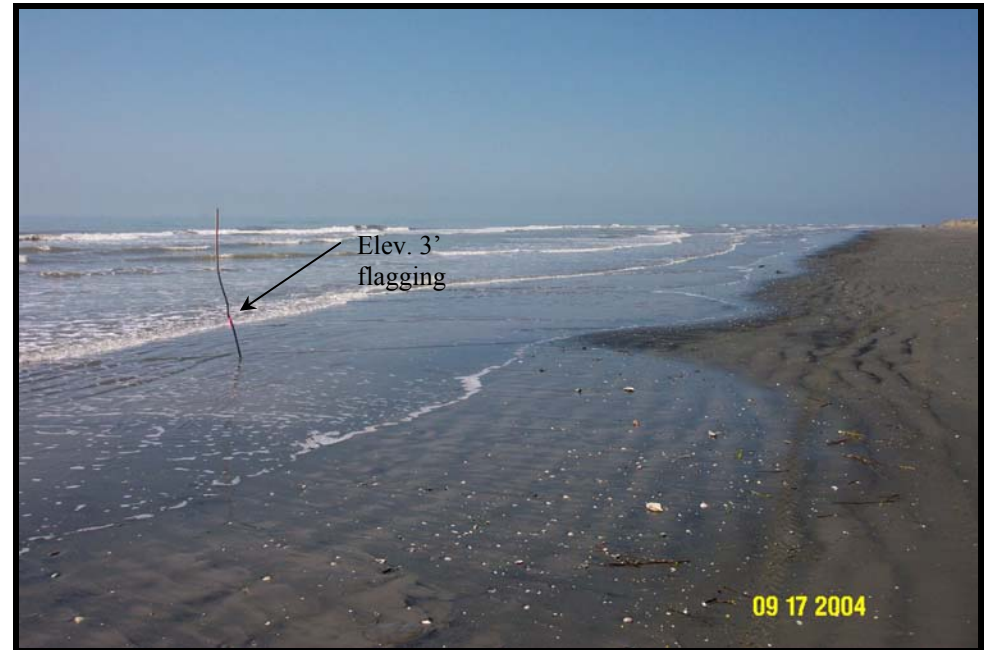
Photo 12. *Beach fill Sta. 168+00, looking west (with view of constructed 50' berm breakpoint stake with 3' elev. flagging on left)*

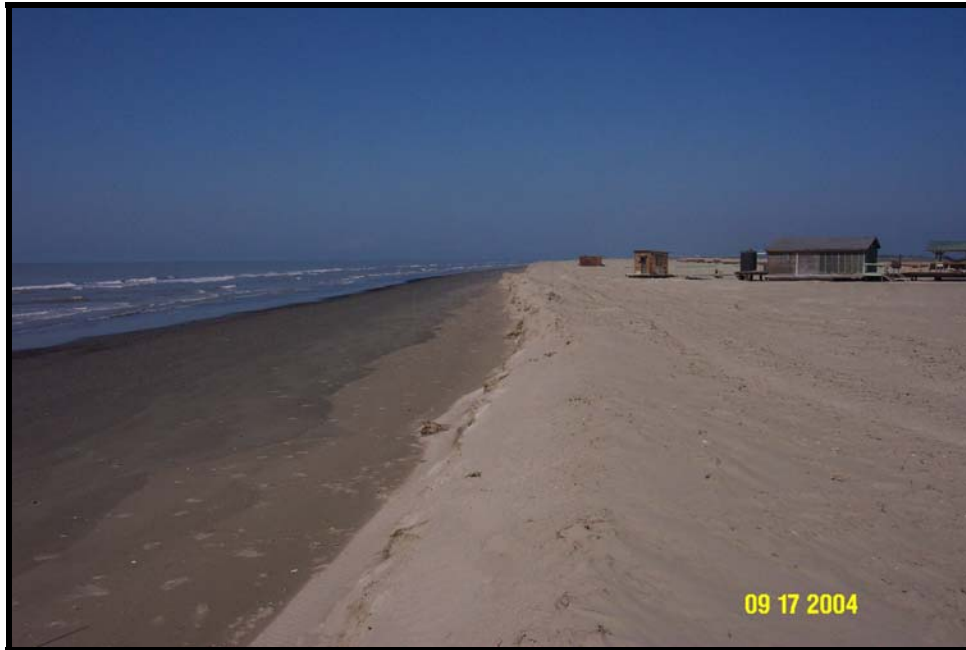
Photo 13. *Gulf side dike erosion at Sta. 170+00, looking west*

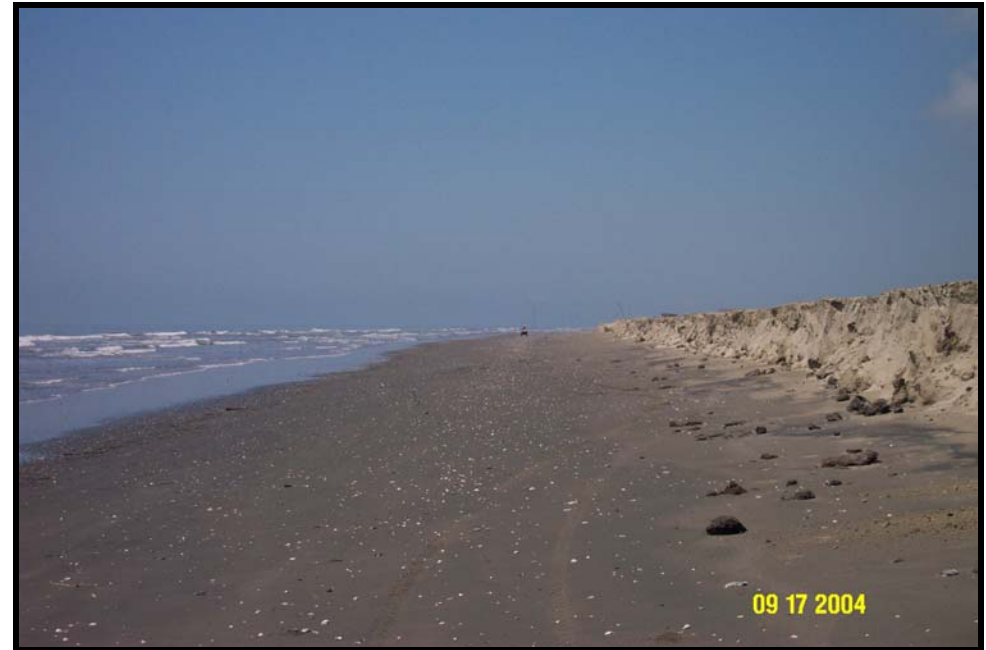
Photo 15. *Front dike/dune erosion Sta. 185+00, looking west*

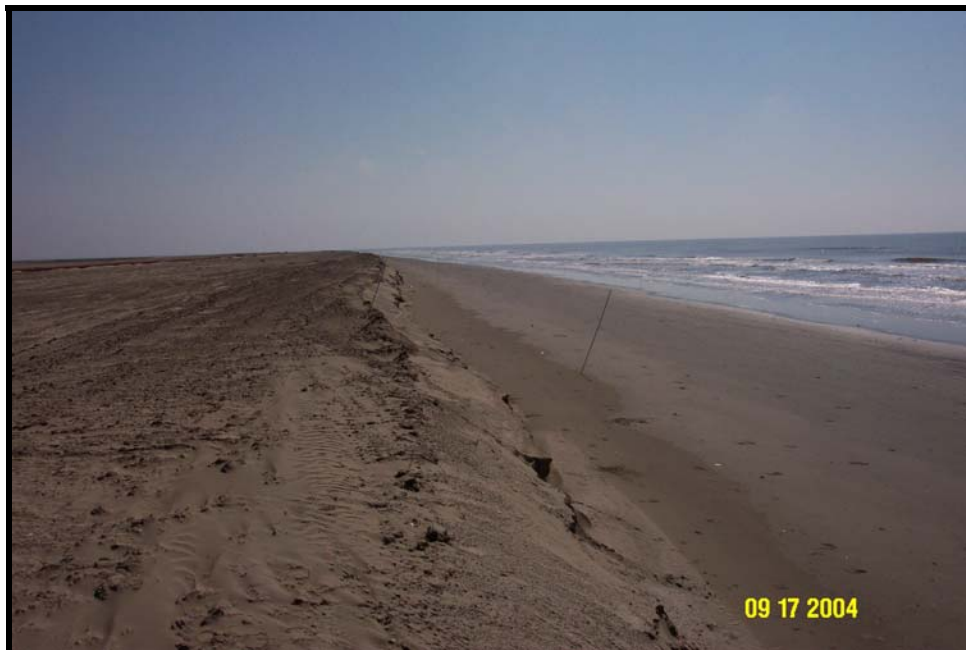
Photo 14. *Gulf side dike erosion at Sta. 170+00, looking east*

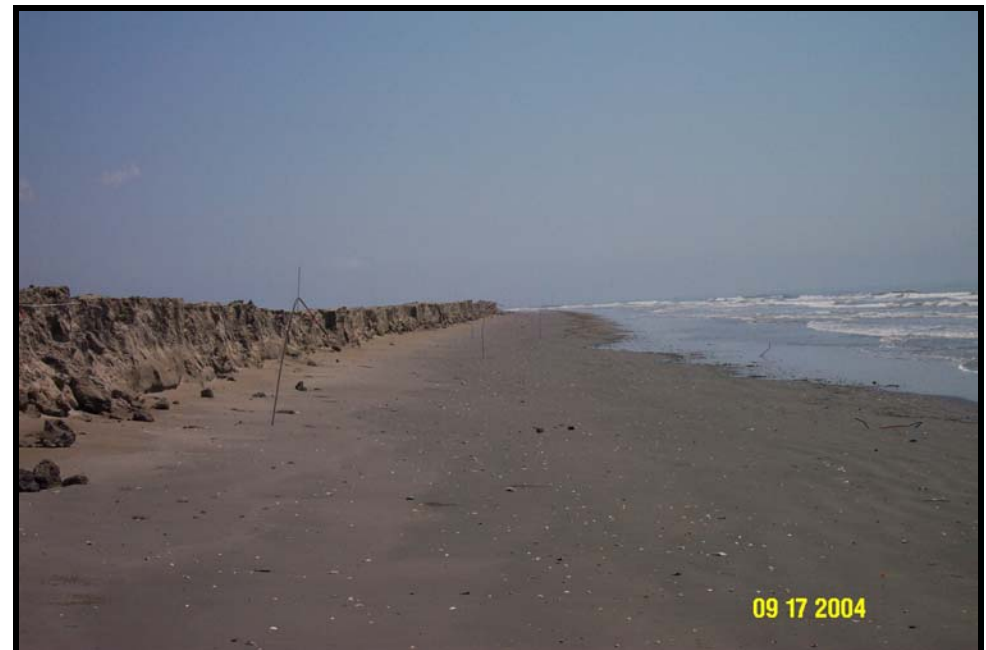
Photo 16. *Front dike/dune erosion Sta. 185+00, looking east*

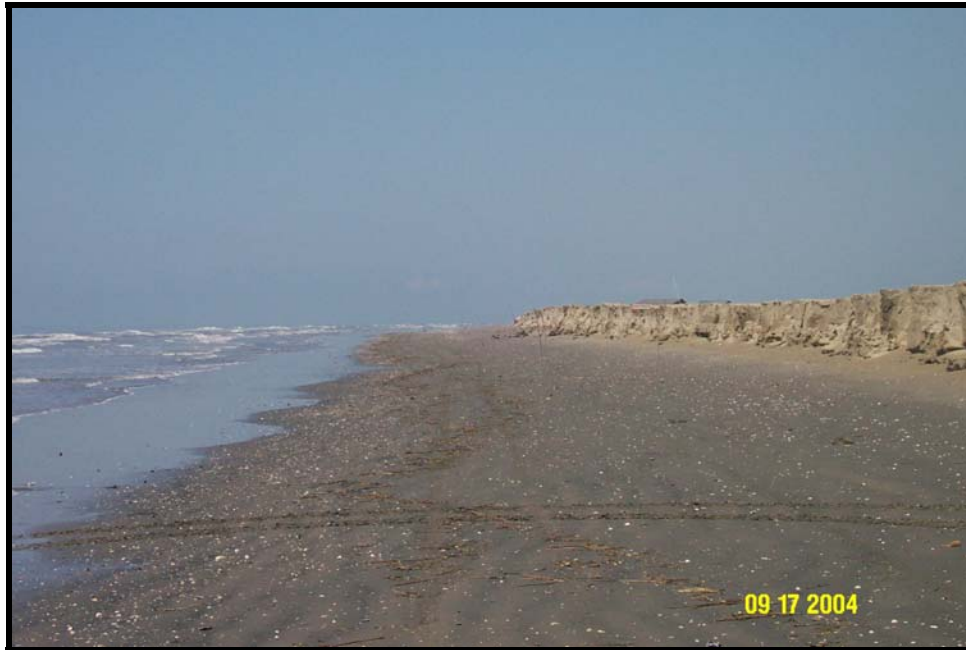
Photo 17. Front dike/dune erosion Sta. 190+00, looking west

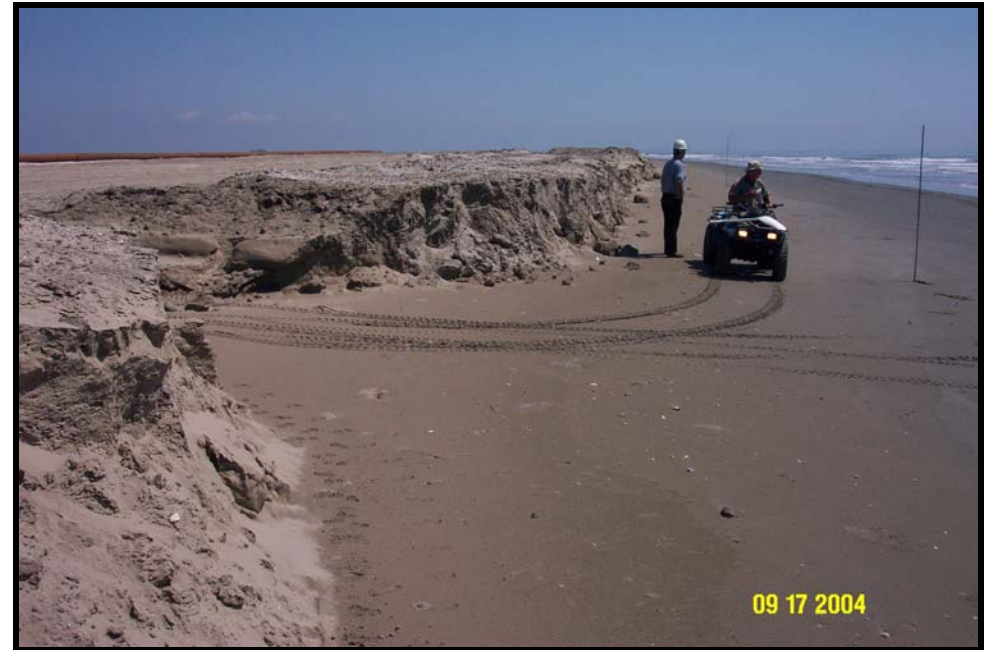
Photo 19. Front dike/dune erosion and ramp washout at Sta. 195+00, looking east

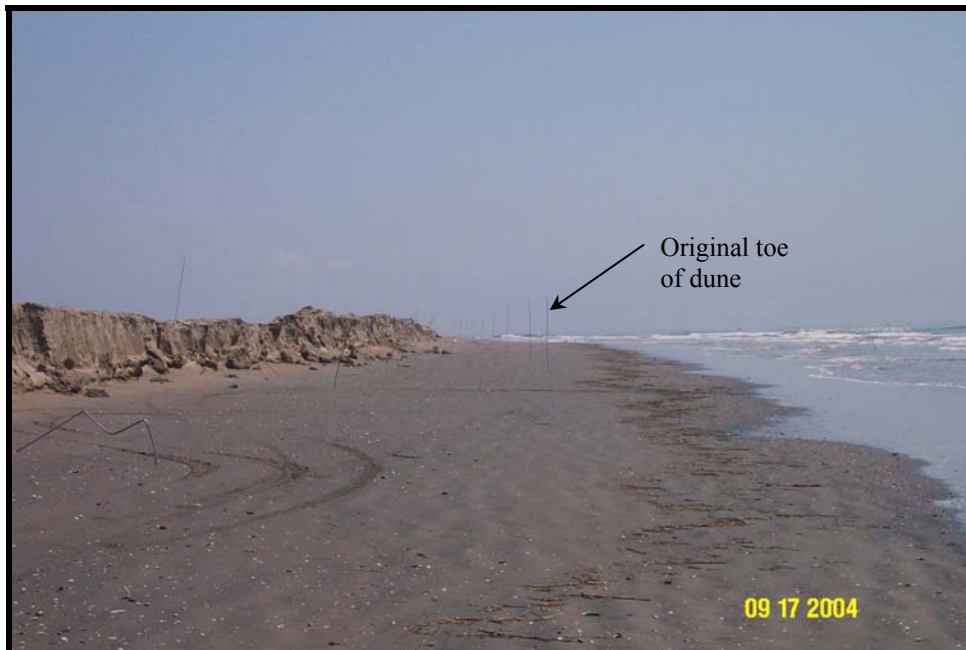
Photo 18. Front dike/dune erosion Sta. 190+00, looking east (with view of toe of dune staking)

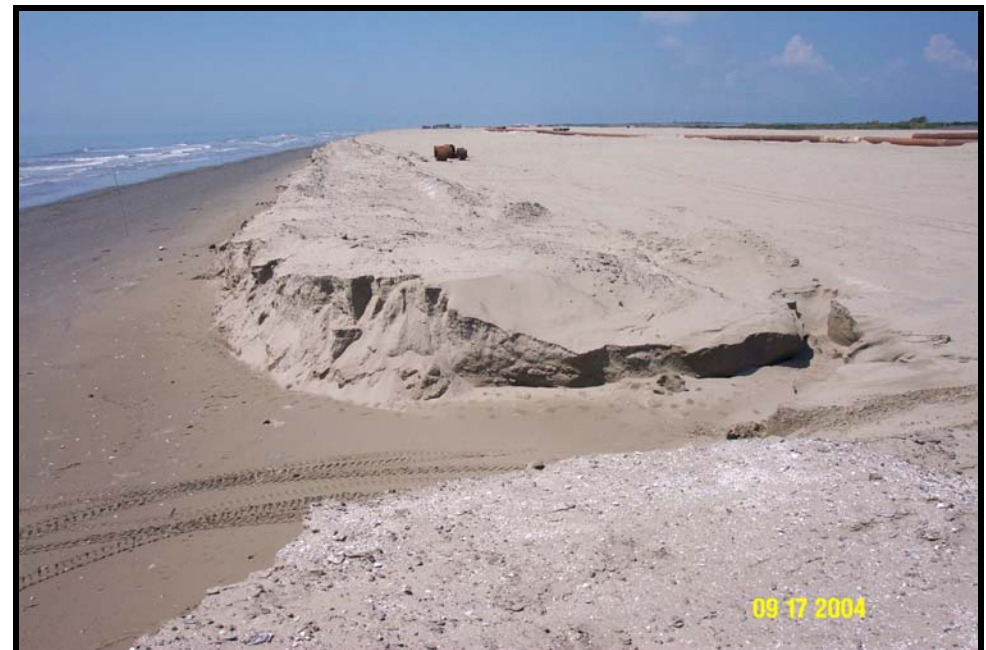
Photo 20. Front dike/dune erosion and ramp washout at Sta. 195+00, looking west

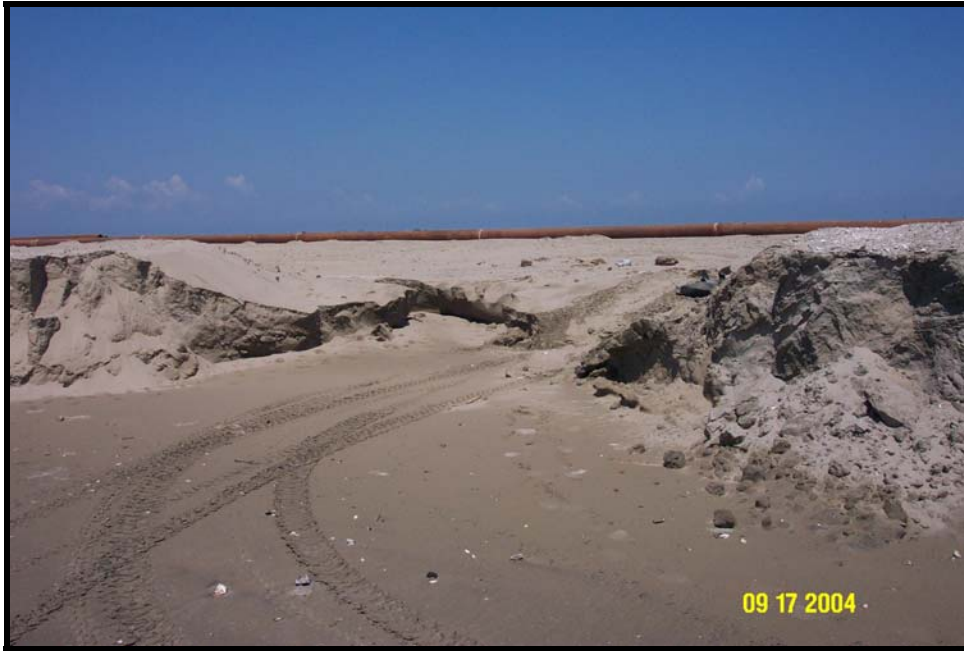
Photo 21. Beach to dune crossover ramp washout at Sta. 195+00, looking north

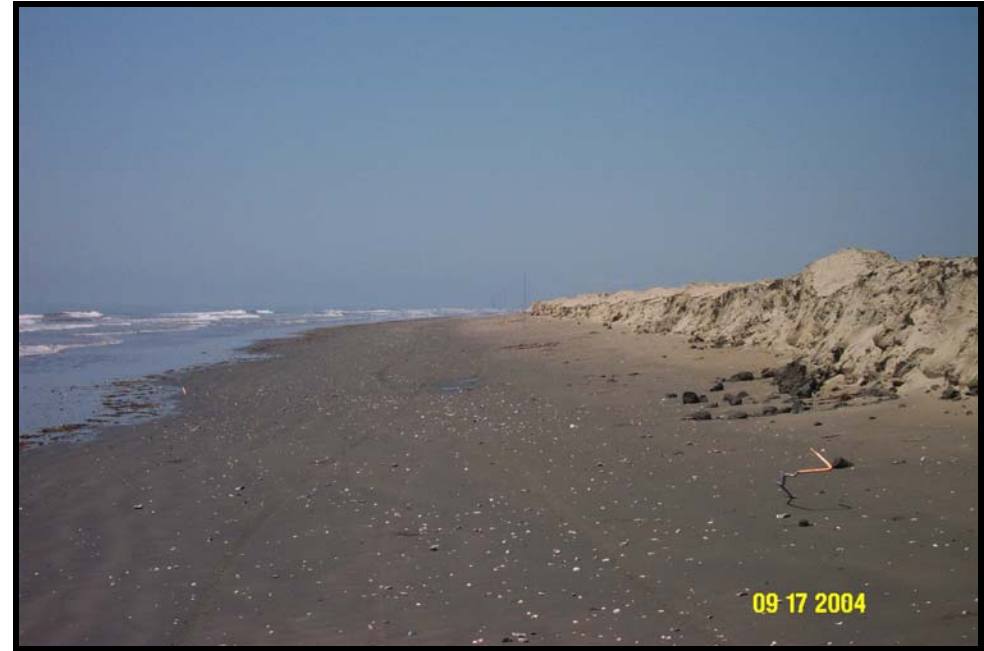
Photo 23. Front dike/dune erosion Sta. 200+00, looking west

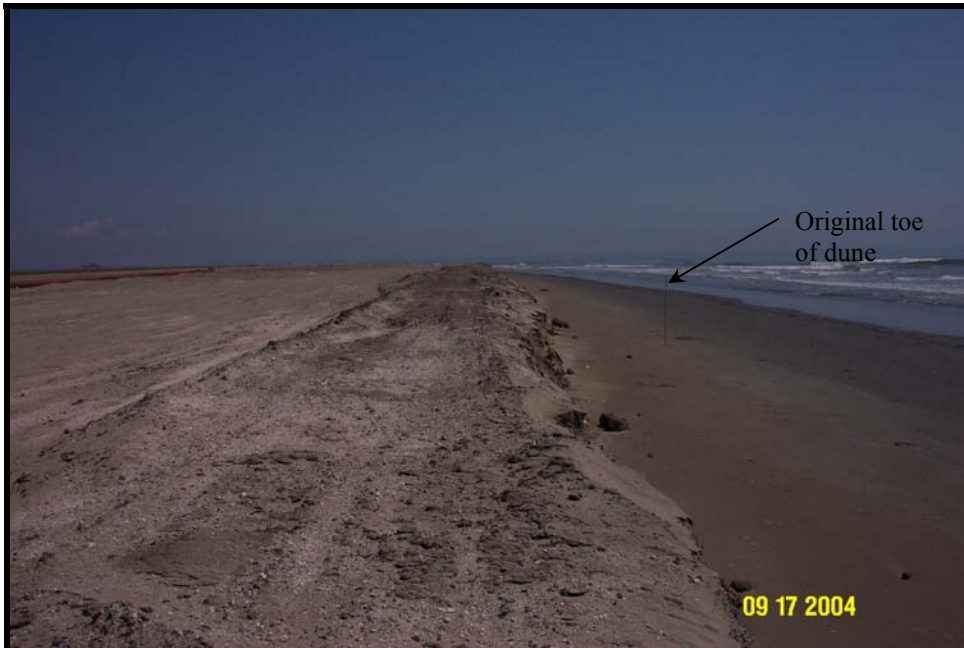
Photo 22. Front dike/dune erosion Sta. 195+00, looking east (with view of toe of dune staking)

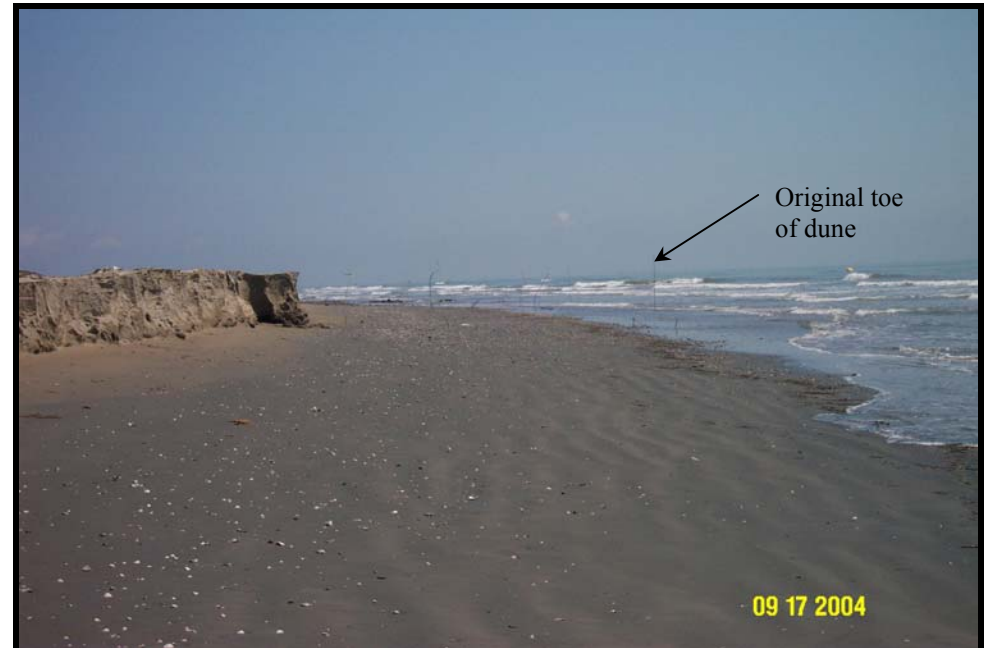
Photo 24. Front dike/dune erosion Sta. 200+00, looking east (with view of toe of dune staking)

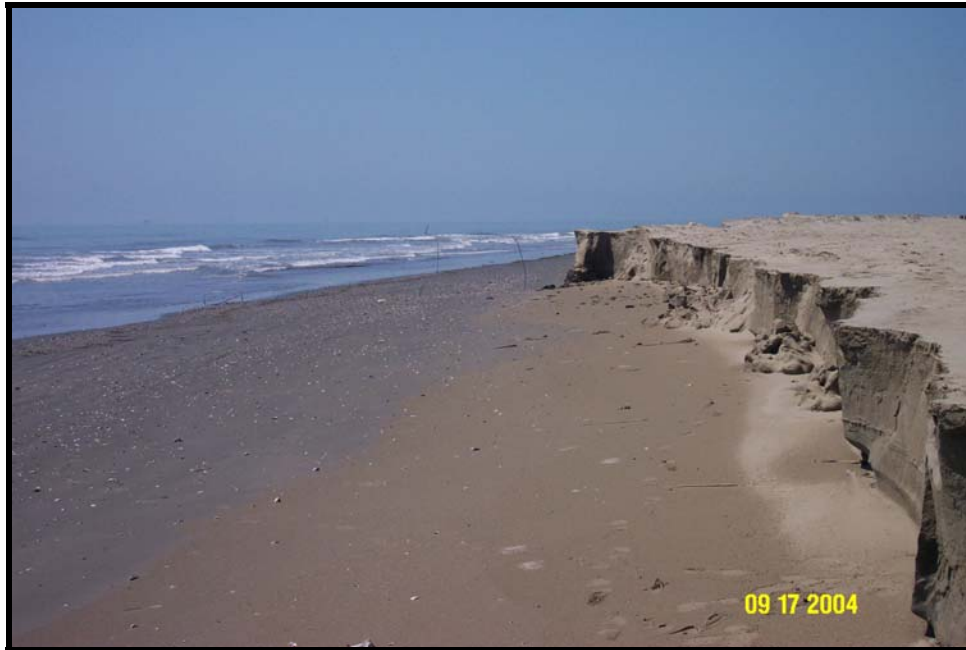
Photo 25. Front dike/dune erosion Sta. 202+00, looking west

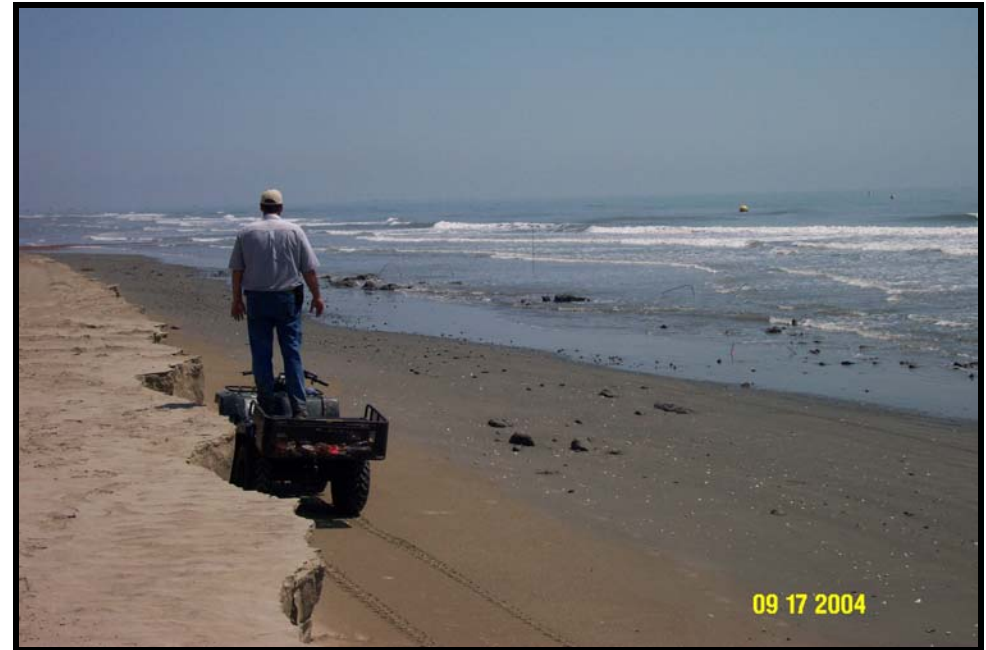
Photo 27. Front dike/dune erosion Sta. 202+00, looking east

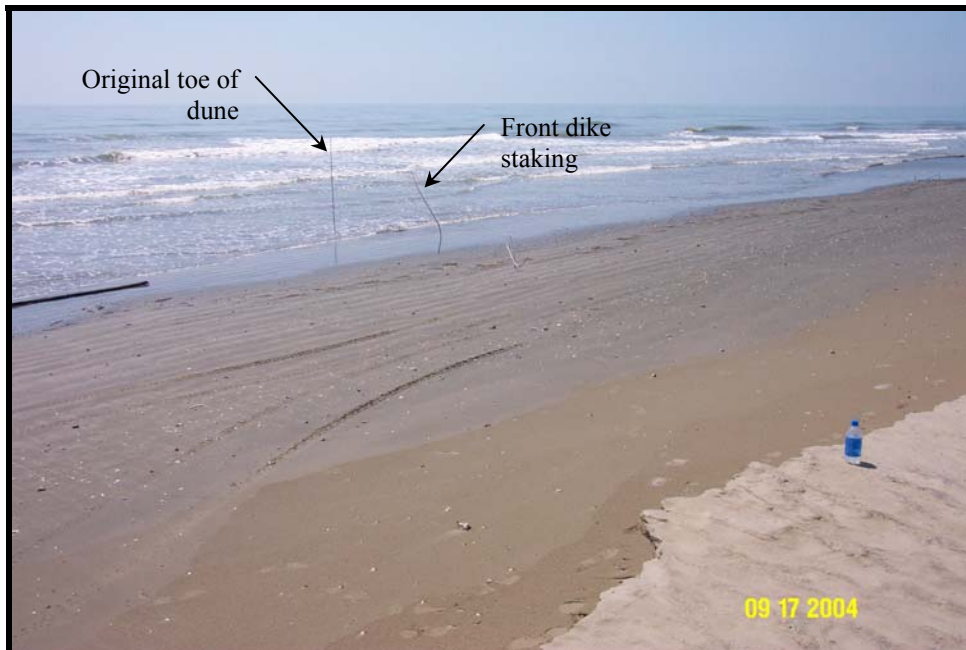
Photo 26. View of toe of dune staking and front dike staking at Sta. 202+00, looking southwest

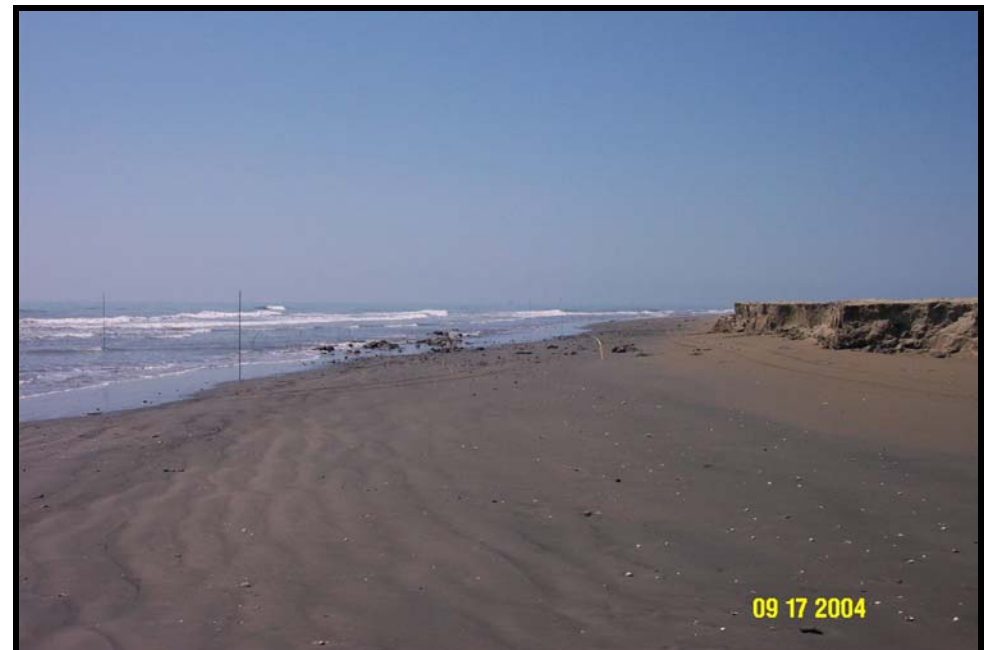
Photo 28. Front dike/dune erosion Sta. 206+00 (east end of project), looking west
